# Appendix C (saltmarsh infeasibility)

## Historic photographic evidence

Kingston Seymour sea defences and photographic evidence of saltmarsh and erosion.

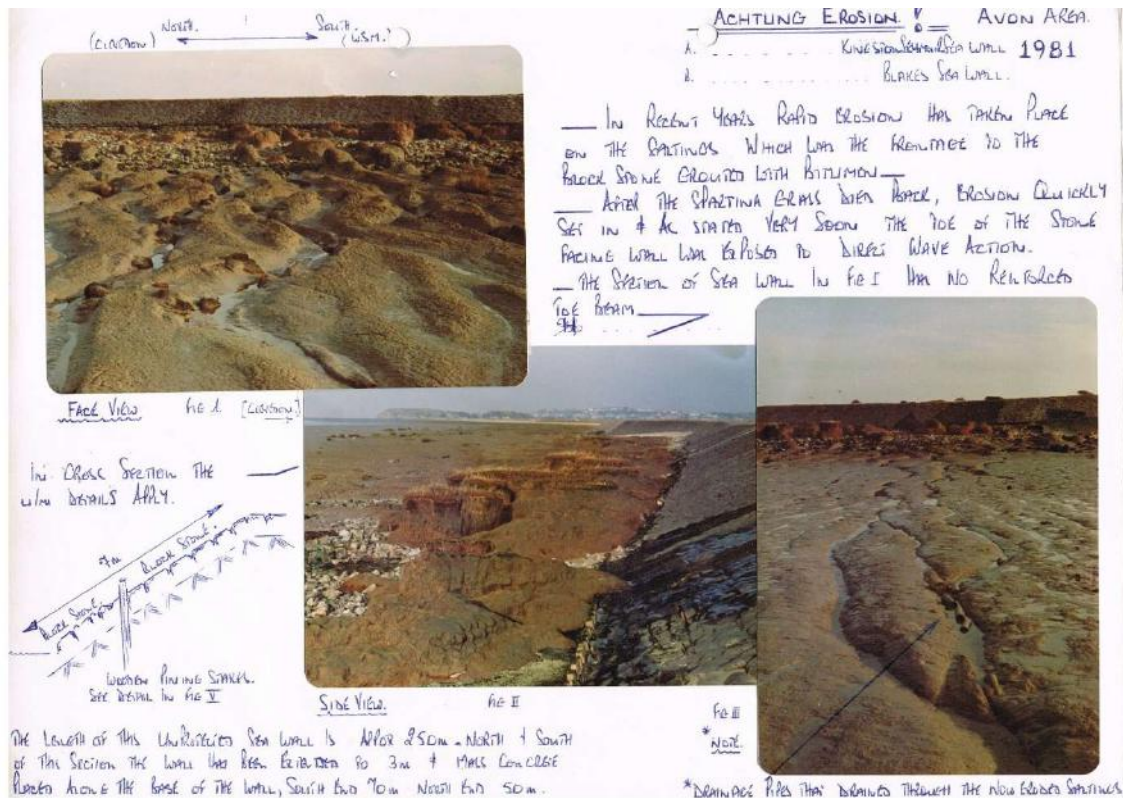
Fig.1

Annotated photograph from 1981 showing erosion prior to construction of the current sea-wall. Spartina grass and drainage outflow pipes are visible

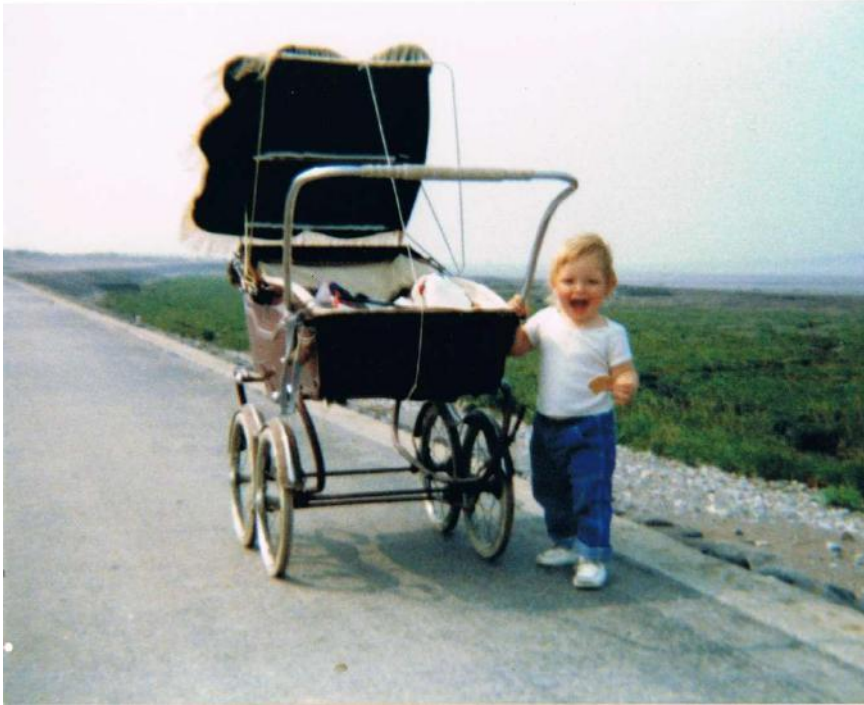
Fig.2

Photograph from 1988 – Spartina grass has flourished, creating a band of saltmarsh

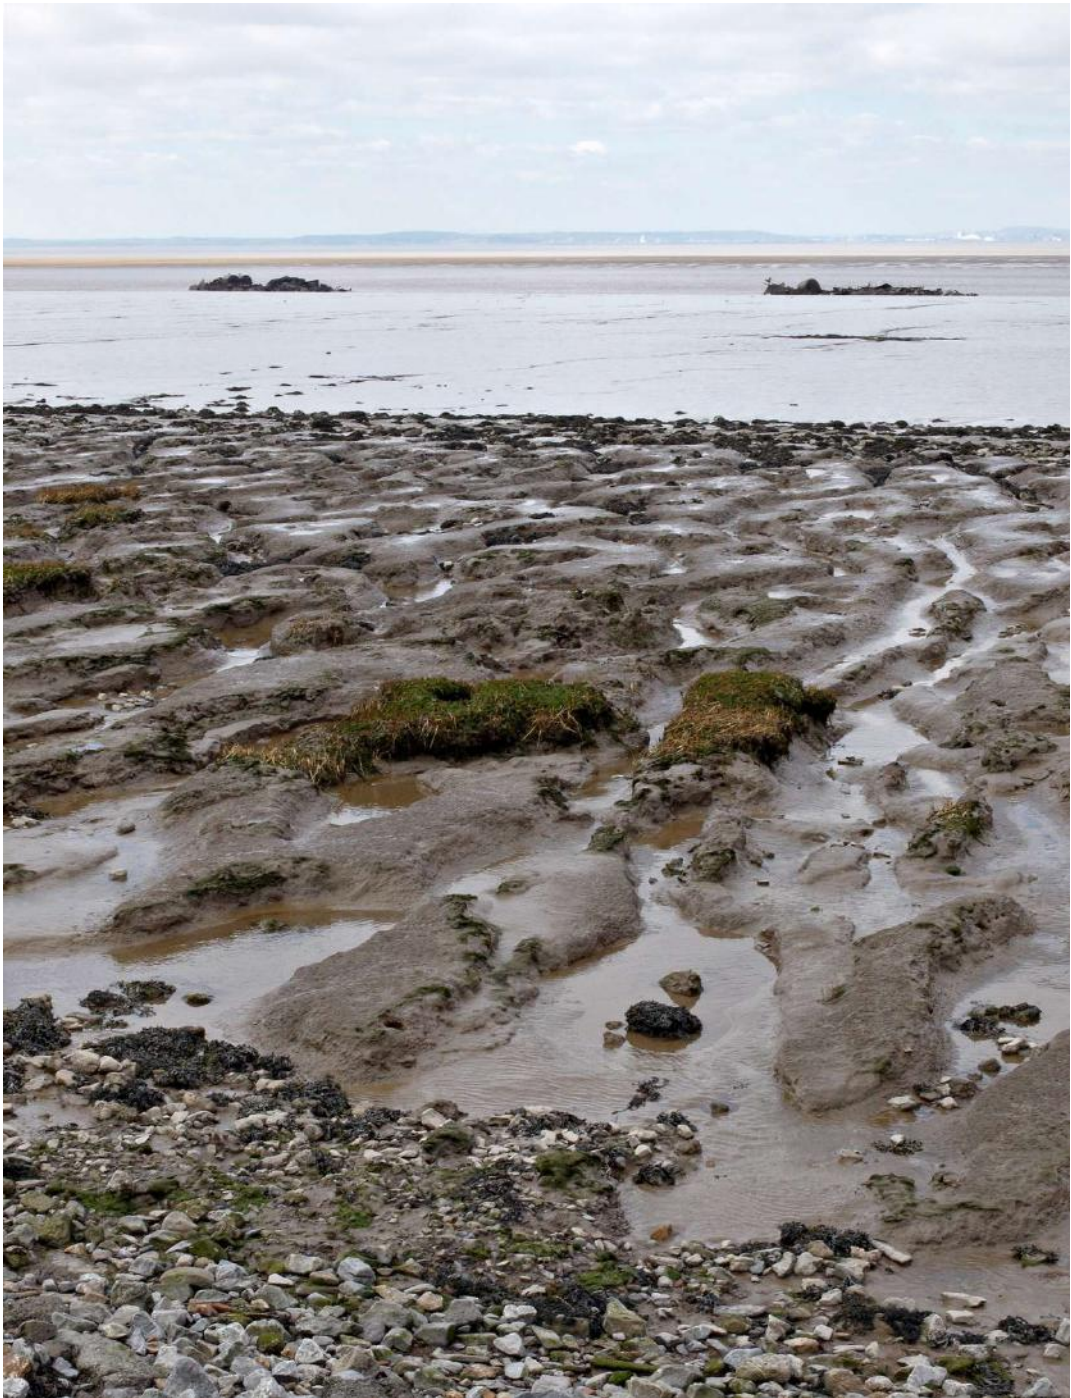
*Fig. 3*

Photograph from 2015 (top) – The tidal flows and siltation have killed off all vegetation and the area is now sterile mud-flat.

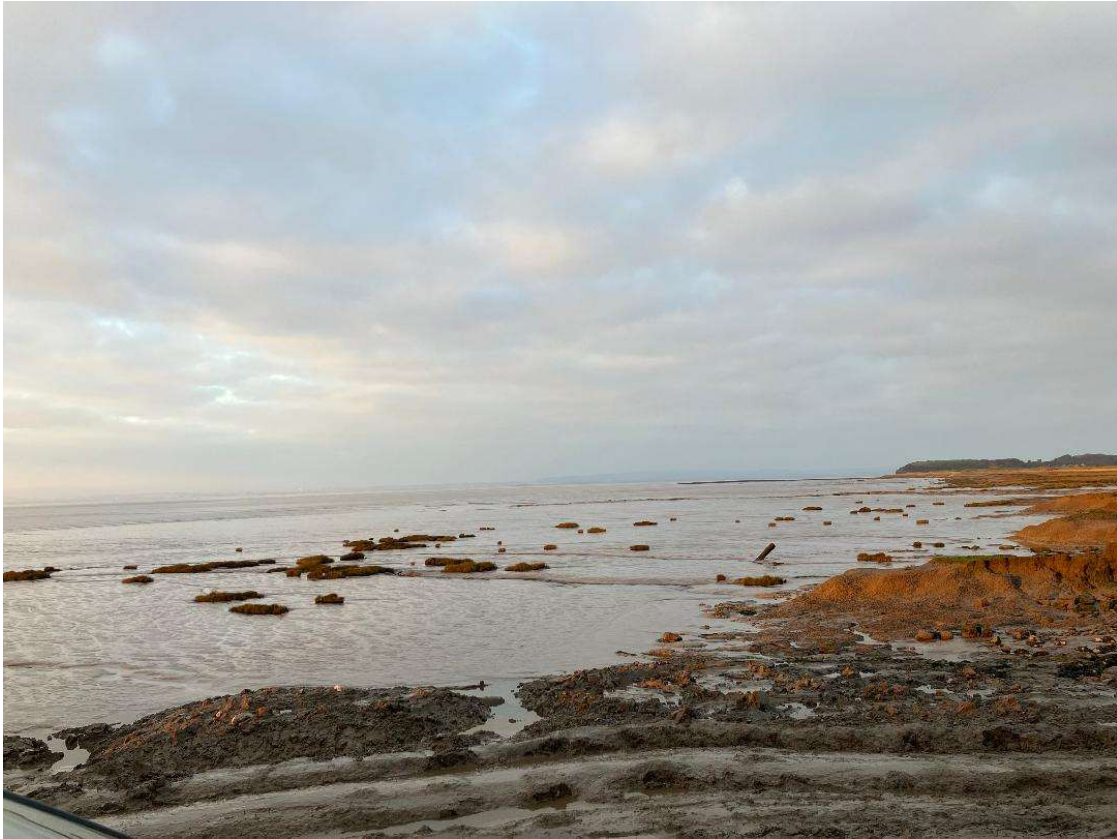
View towards Clevedon – erosion of salt marsh reduced to mud flats caused by strong tides  
(Nov 2024)
